Summary

English Heritage asked Geospatial Survey Solutions and Deri Jones & Associates (GSS/DJA)

to provide a laser survey of St. Peters church, in Barton-upon-Humber, England. The requirement was a full laser scan survey of the site to produce a record of the floor heights for monitoring of subsidence, and to allow photographs of the 1980's archaeological excavations to be used for photogrammetry. The initial survey was undertaken in August 2007 and we returned in 2008 to capture a further set of data to allow comparison and identify areas of subsidence.

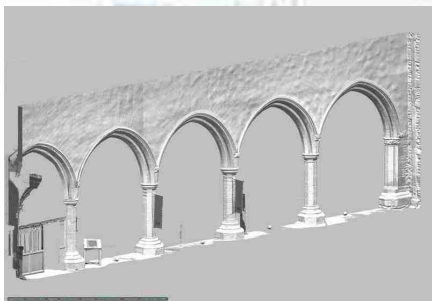
on the stability of the building, survey references were placed outside the church on separate structures to minimise movement. These could also be used if an external survey was required in the future. The FARO LS 880 laser scanner was used to capture the points, the separate

scans were tied together using references gathered by our Total Station.

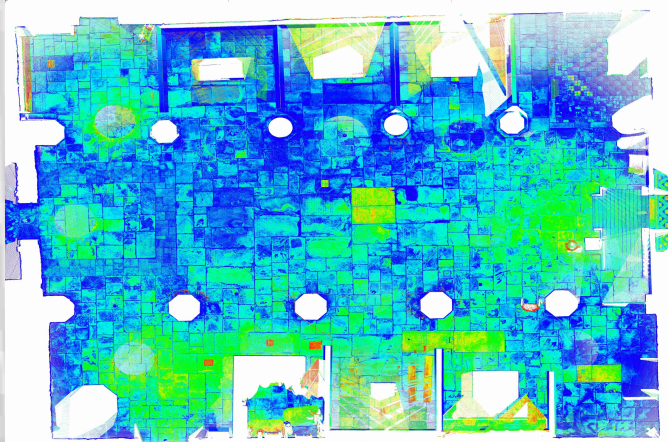
The second set of scans were processed in a similar way, but once an orthographic image was taken, we used it to trace a stone-by-stone CAD drawing of the church floor, on this we

recorded the heights of individual flagstones compared with the previous years results. Over a thousand flagstones were recorded, with some 2500 individual heights taken from the scan data.
