Summary

LS880 - Yacht fairing review

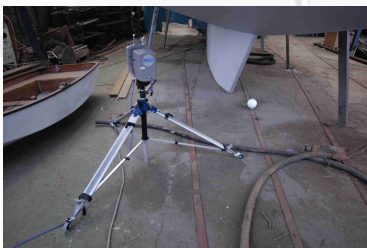
Using the FARO LS880 laser scanner, an existing steel hull was scanned and

compared with the original design model to check for accuracy and fairness. This technology is equally

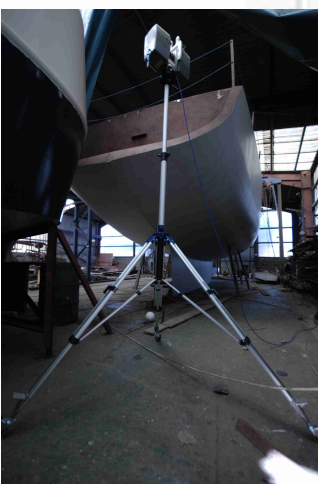
Scanning is carried out in conjunction with our 3D total station, allowing millimetre

accuracy to be achieved for critical areas. The scans are combined and cleaned to create an accurate 3D point cloud of the hull or mould.

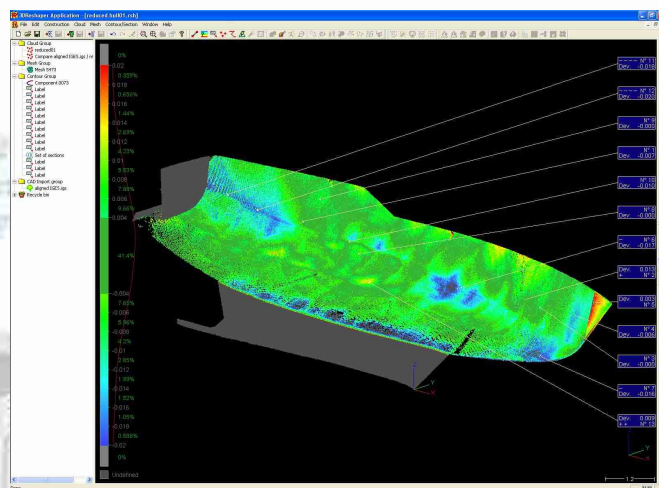
For reverse engineering, the point data is split up to the various component surfaces and imported individually to our CAD system. The individual point clouds are then used to create a watertight set of NURBS surfaces that can

be transferred to most CAD packages, along with a comparison map showing the relative accuracy of the fair surfaces to the original scan data.

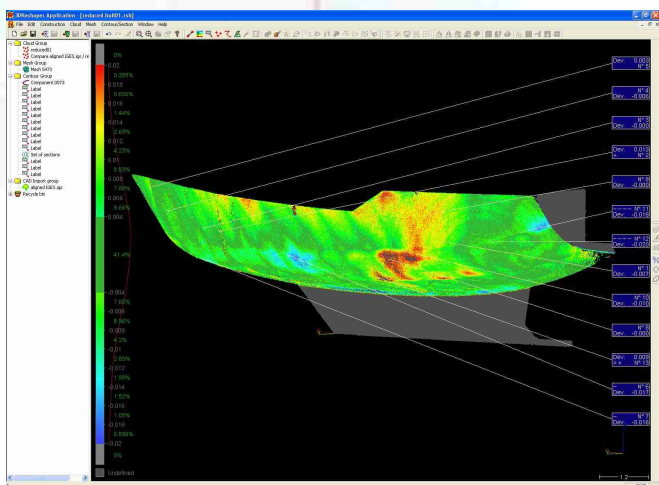
The fairing map shows that some 70% of the hull lies within $\pm 8\text{mm}$ of the design surface and over 86% within $\pm 10\text{mm}$. It is clear on the map where the main areas of distortion lie - along the seam between the rolled chine plates and the side plates and the fit of the bow chine plate. The large red area at the upper bow is an anomaly in the original design surface, rather than a problem with the construction or scanning.
